*VOLUME 82, PART 1*

# GEOHYDROLOGY AND THE DECLINE OF ANGKOR

HENG L. THUNG

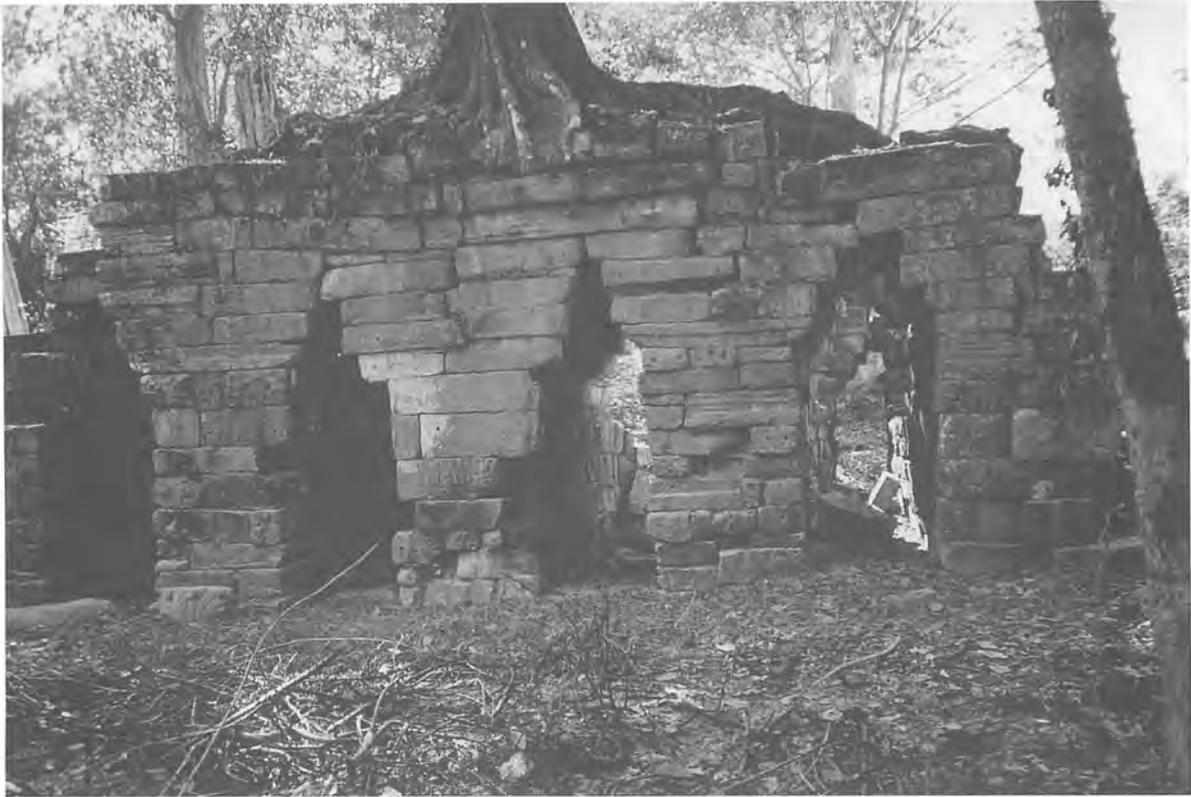
Fig. 1 The old stone bridge shows the stone-paved canal bottom. This bridge is located over the Siem Reap canal east of Angkor Thom.

The Hungarian team reported much field evidence, such as the downward erosion of the river bottoms. The process is manifested by the changes in the depth of these bottoms. For instance, east of Angkor Thom there are the ruins of an ancient bridge over a diverted channel of the Siem Reap River (see figs. 1 and 2). The arches are footed on a sandstone ledge 2.5 meters deep over which the water would spill; this shows the sandstone bottom of the original channel. However, during the dry season the water now flows through a breach of some four or five meters below the original depth of the ancient bridge footing. This is a reliable gauge of the amount of down-cutting which took place since the construction of the bridge.

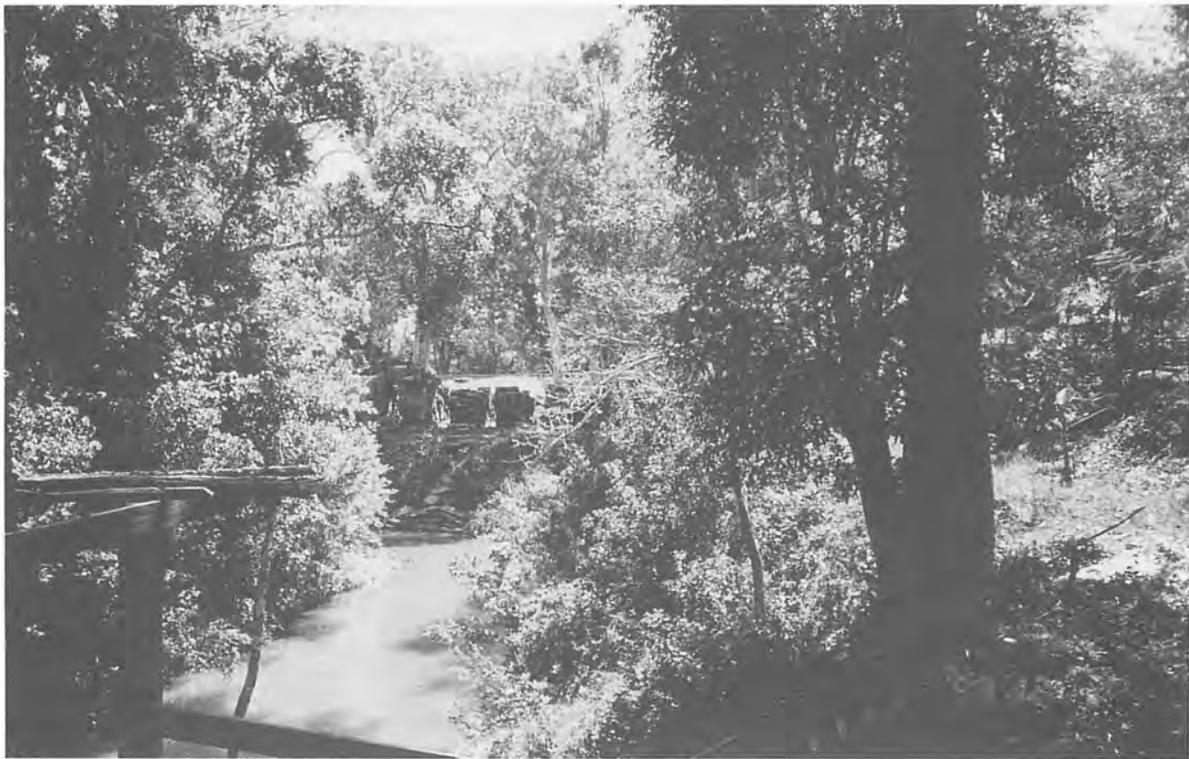
Fig. 2 The present Siem Reap canal has scoured a channel four feet below the original canal bottom shown by the remains of the bridge footings in the center of the photograph. The terrace on the right shows the original canal bottom.

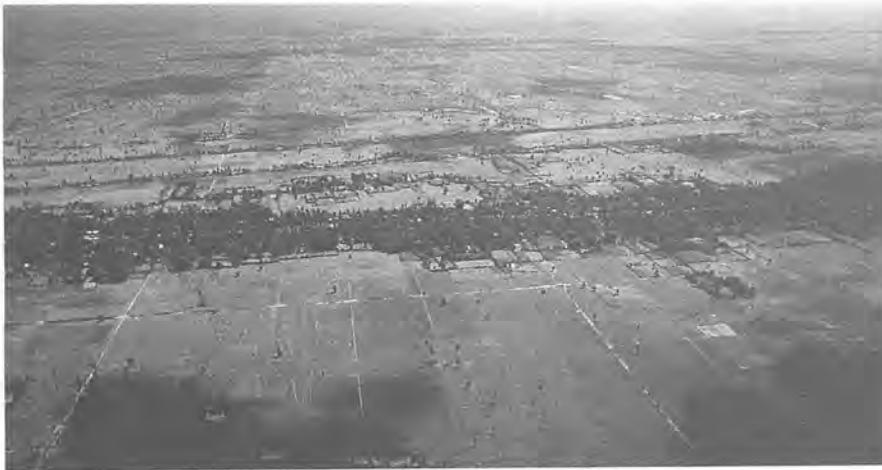
Fig. 3 The dikes of the Prek Thnal Dak shipping canal are clearly visible, while rice is growing in the canal bottom. A linear village is parallel to the ancient canal and has developed along a new road.

The uplift can best be measured along the profile of the large Prek Thnal Dak canal east of Angkor (fig. 3). During its construction the canal would have been level, not unlike the many canals in the region of Bangkok. The elevation is now twenty-five meters at the terminus of the canal thirty kilometers north of the coastline, indicating an uplift of twenty meters over this distance. This is significantly more than the down-cutting around Angkor. Erosion usually lags behind the uplift of the land; thus this indicates that the erosion of the stream beds is continuing today.

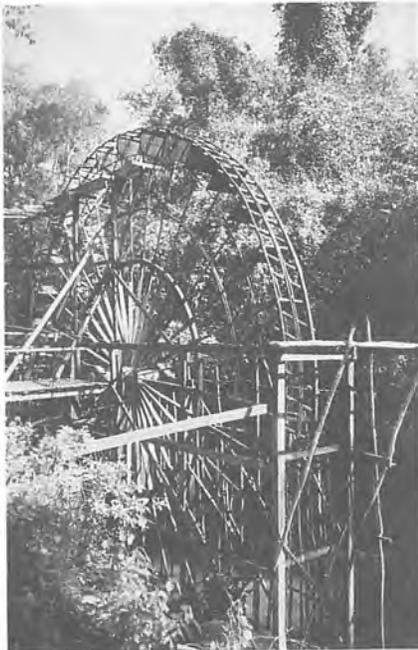
Fig. 4 A replica of the many ancient *norias*, or water wheels, is still used today to water the forestry nursery at Angkor.

Large water wheels along the present Siem Reap River lift up water to irrigate the fields during the dry season (fig. 4). These water wheels, or *norias*, were known to the early Egyptians. These devices, still in use in Cambodia, may be remnants from the past. They were used to raise water from the deepening water level in the main streams to parallel canals along the ancient waterways. Signs of these small parallel channels are visible on the aerial photographs.

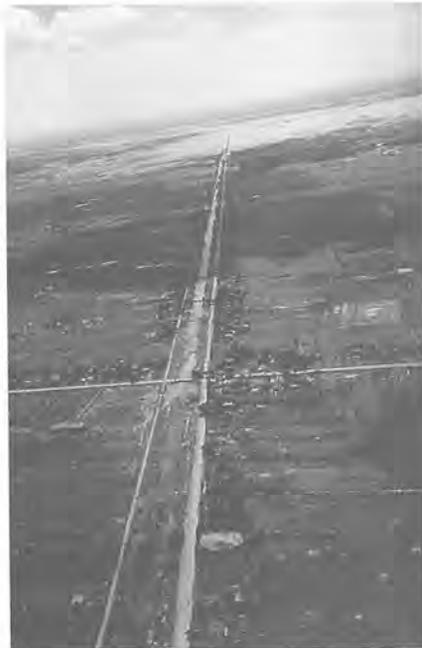
Fig. 5 A Pol Pot period canal further east of Angkor is a modern version of the ancient Khmer shipping canal.

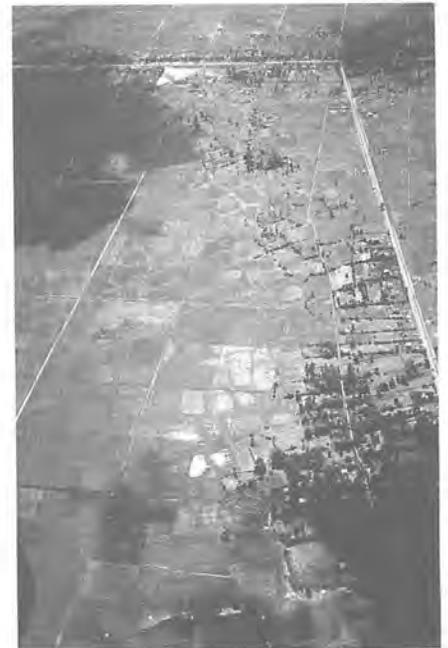
Fig. 6 Ancient field patterns show through the new rice fields because of the different soil textural conditions caused by ancient disturbances of the soil.
